WATER SUPPLY AND WASTEWATER FEASIBILITY STUDY

Quiemuth Village

Submitted by: Olson Engineering Inc. (A Division of MacKay Sposito)

June 2, 2023

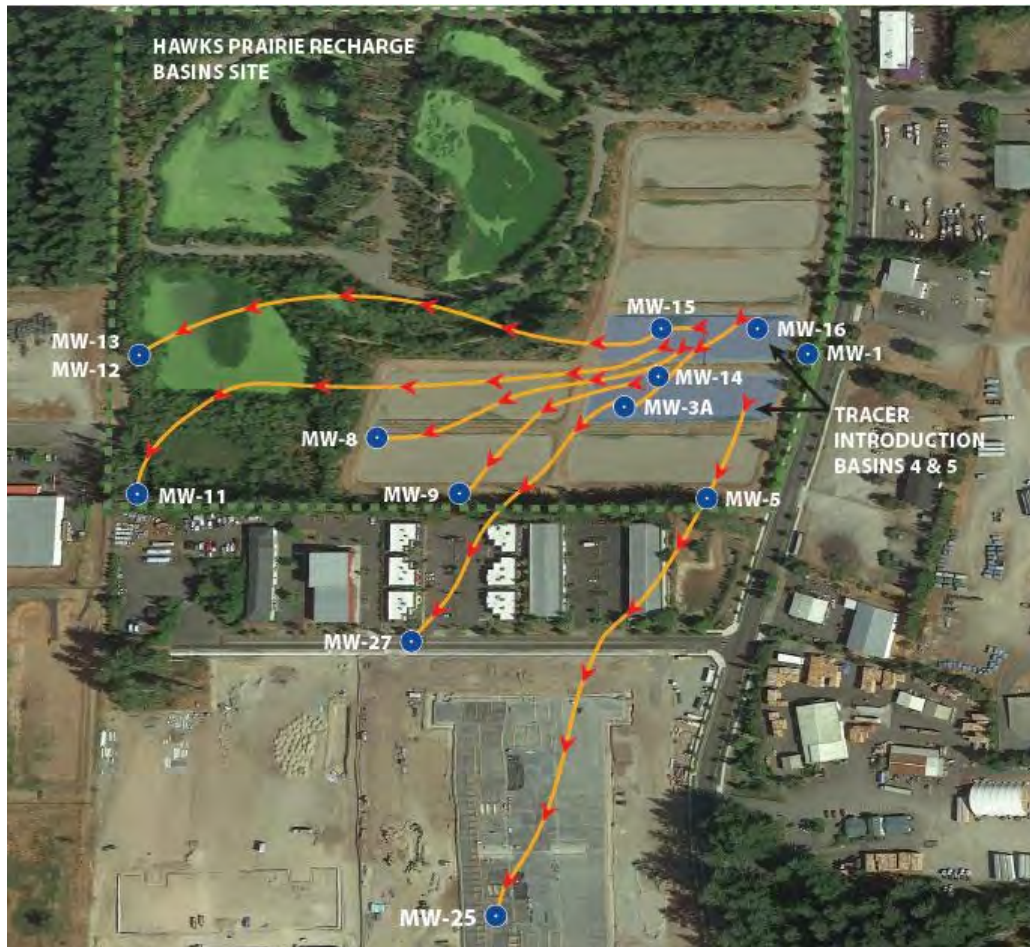
Figure 4-4. Reclaimed Water Flow Directions (Shallow Aquifer)

With the monitoring network established, LOTT conducted a 10-month tracer test in 2018, to track the movement of reclaimed water and understand changes in residual chemical concentrations that take place within a half mile from the Hawks Prairie site. Two non-toxic, inert chemicals (potassium bromide and sulfur hexafluoride) were introduced to the reclaimed water entering Basins 4 and 5. Sampling data from 26 of the monitoring wells were used to characterize the flow direction and travel time of reclaimed water movement in groundwater away from the infiltration site. The tracer test data confirmed the general understanding that flow in the shallow aquifer at this location is generally to the south and west (see Figure 4-4).

Travel times vary widely as reclaimed water moves away from the site due to the heterogeneity of the hydrogeologic system, but in general it takes 30-40 days for reclaimed water to move from the infiltration basins through the unsaturated zone and into the shallow aquifer. Some reclaimed water advances into the deep aquifer in this time frame as well.

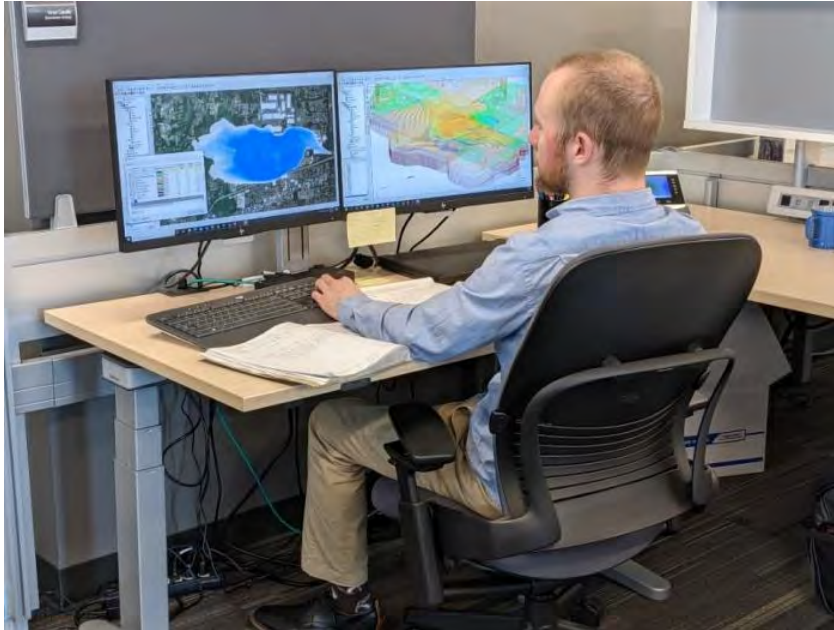
Figure 4-7. Computer Modeling of Groundwater

The results of the tracer test, as well as the increased understanding of the local area hydrogeology through the expanded monitoring well network, were used to update an existing hydrogeologic model to estimate reclaimed water flow paths and residual chemical concentrations within a 30 square mile area and out to 100 years into the future. The groundwater flow model platform of MODFLOW and the chemical fate and transport modeling platform of MT3DMS were used to conduct this work.

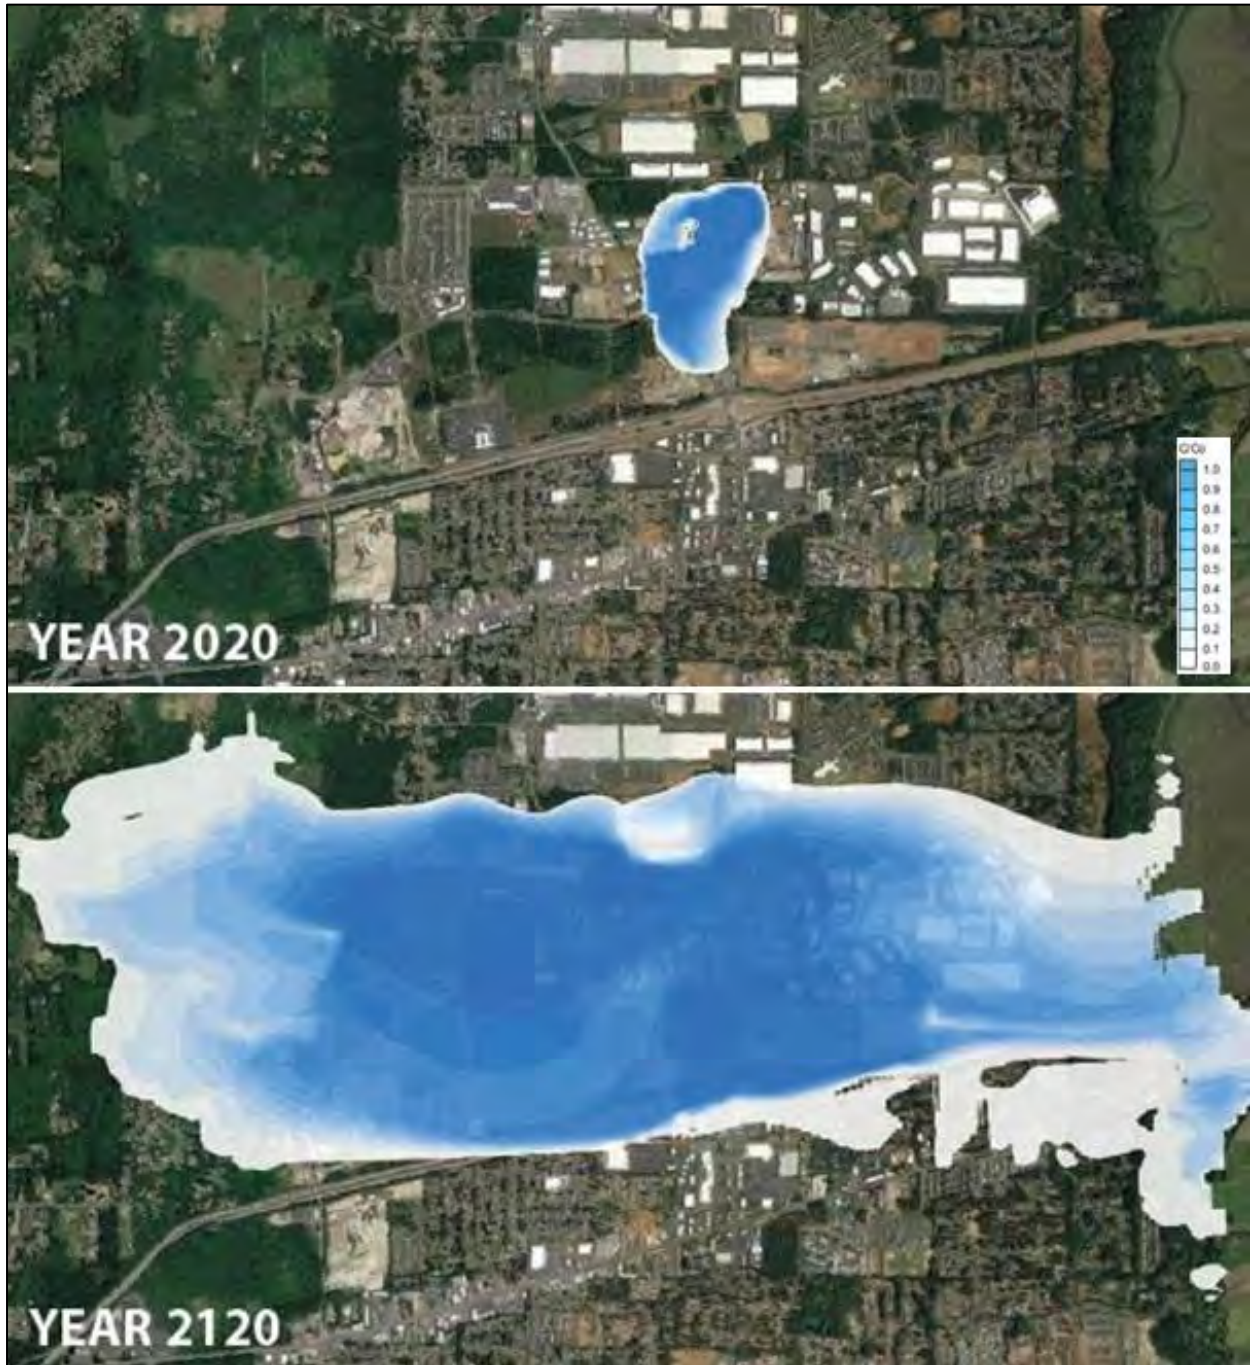
Figure 4-9. Modeled Extent of Reclaimed Water Movement (2020 and 2120; Shallow Aquifer)

The groundwater model was then calibrated to conditions observed from the field investigations (e.g., groundwater elevations) and the tracer test (e.g., travel times of the tracers), and used to estimate the extent of reclaimed water movement over a 100-year period from present day. An initial transient flow simulation was first used to reflect historical annual average recharge rates from 2006 to 2020 (ranging from 0 to 0.99 mgd), to characterize the extent of reclaimed water movement by 2020. A second transient simulation incorporated anticipated increases in recharge rates to reflect planned growth in LOTT’s service area. Projected annual average flow rates were increased from 0.5 mgd in 2020 to 4.2 mgd by 2120. Sensitivity analyses were also performed to evaluate the variability in the key model elements of dispersion, porosity, and recharge, the latter being explored to understand potential impacts of climate change and development upon future groundwater conditions. The modeled extent of reclaimed water movement in the shallow aquifer is depicted in Figure 4-9, wherein the color depicts the portion of groundwater at a given location that is comprised of water that originated as reclaimed water infiltrated at the Hawks Prairie site. This is characterized as a ratio shown as C/C_0 (see Section 4.5 for further definition). The values of this ratio range from 0 (the white fringe, indicating essentially no presence of water infiltrated at the Hawks Prairie site) to 1 (the dark blue, indicating groundwater is comprised fully of water that was infiltrated at the Hawks Prairie site).
