**TSP Cleanup Action Plan/
Phase II Environmental Assessment**

**Lacey Gateway Parcels A and B
Lacey, Washington**

Project No. T-6537-1

September 21, 2012

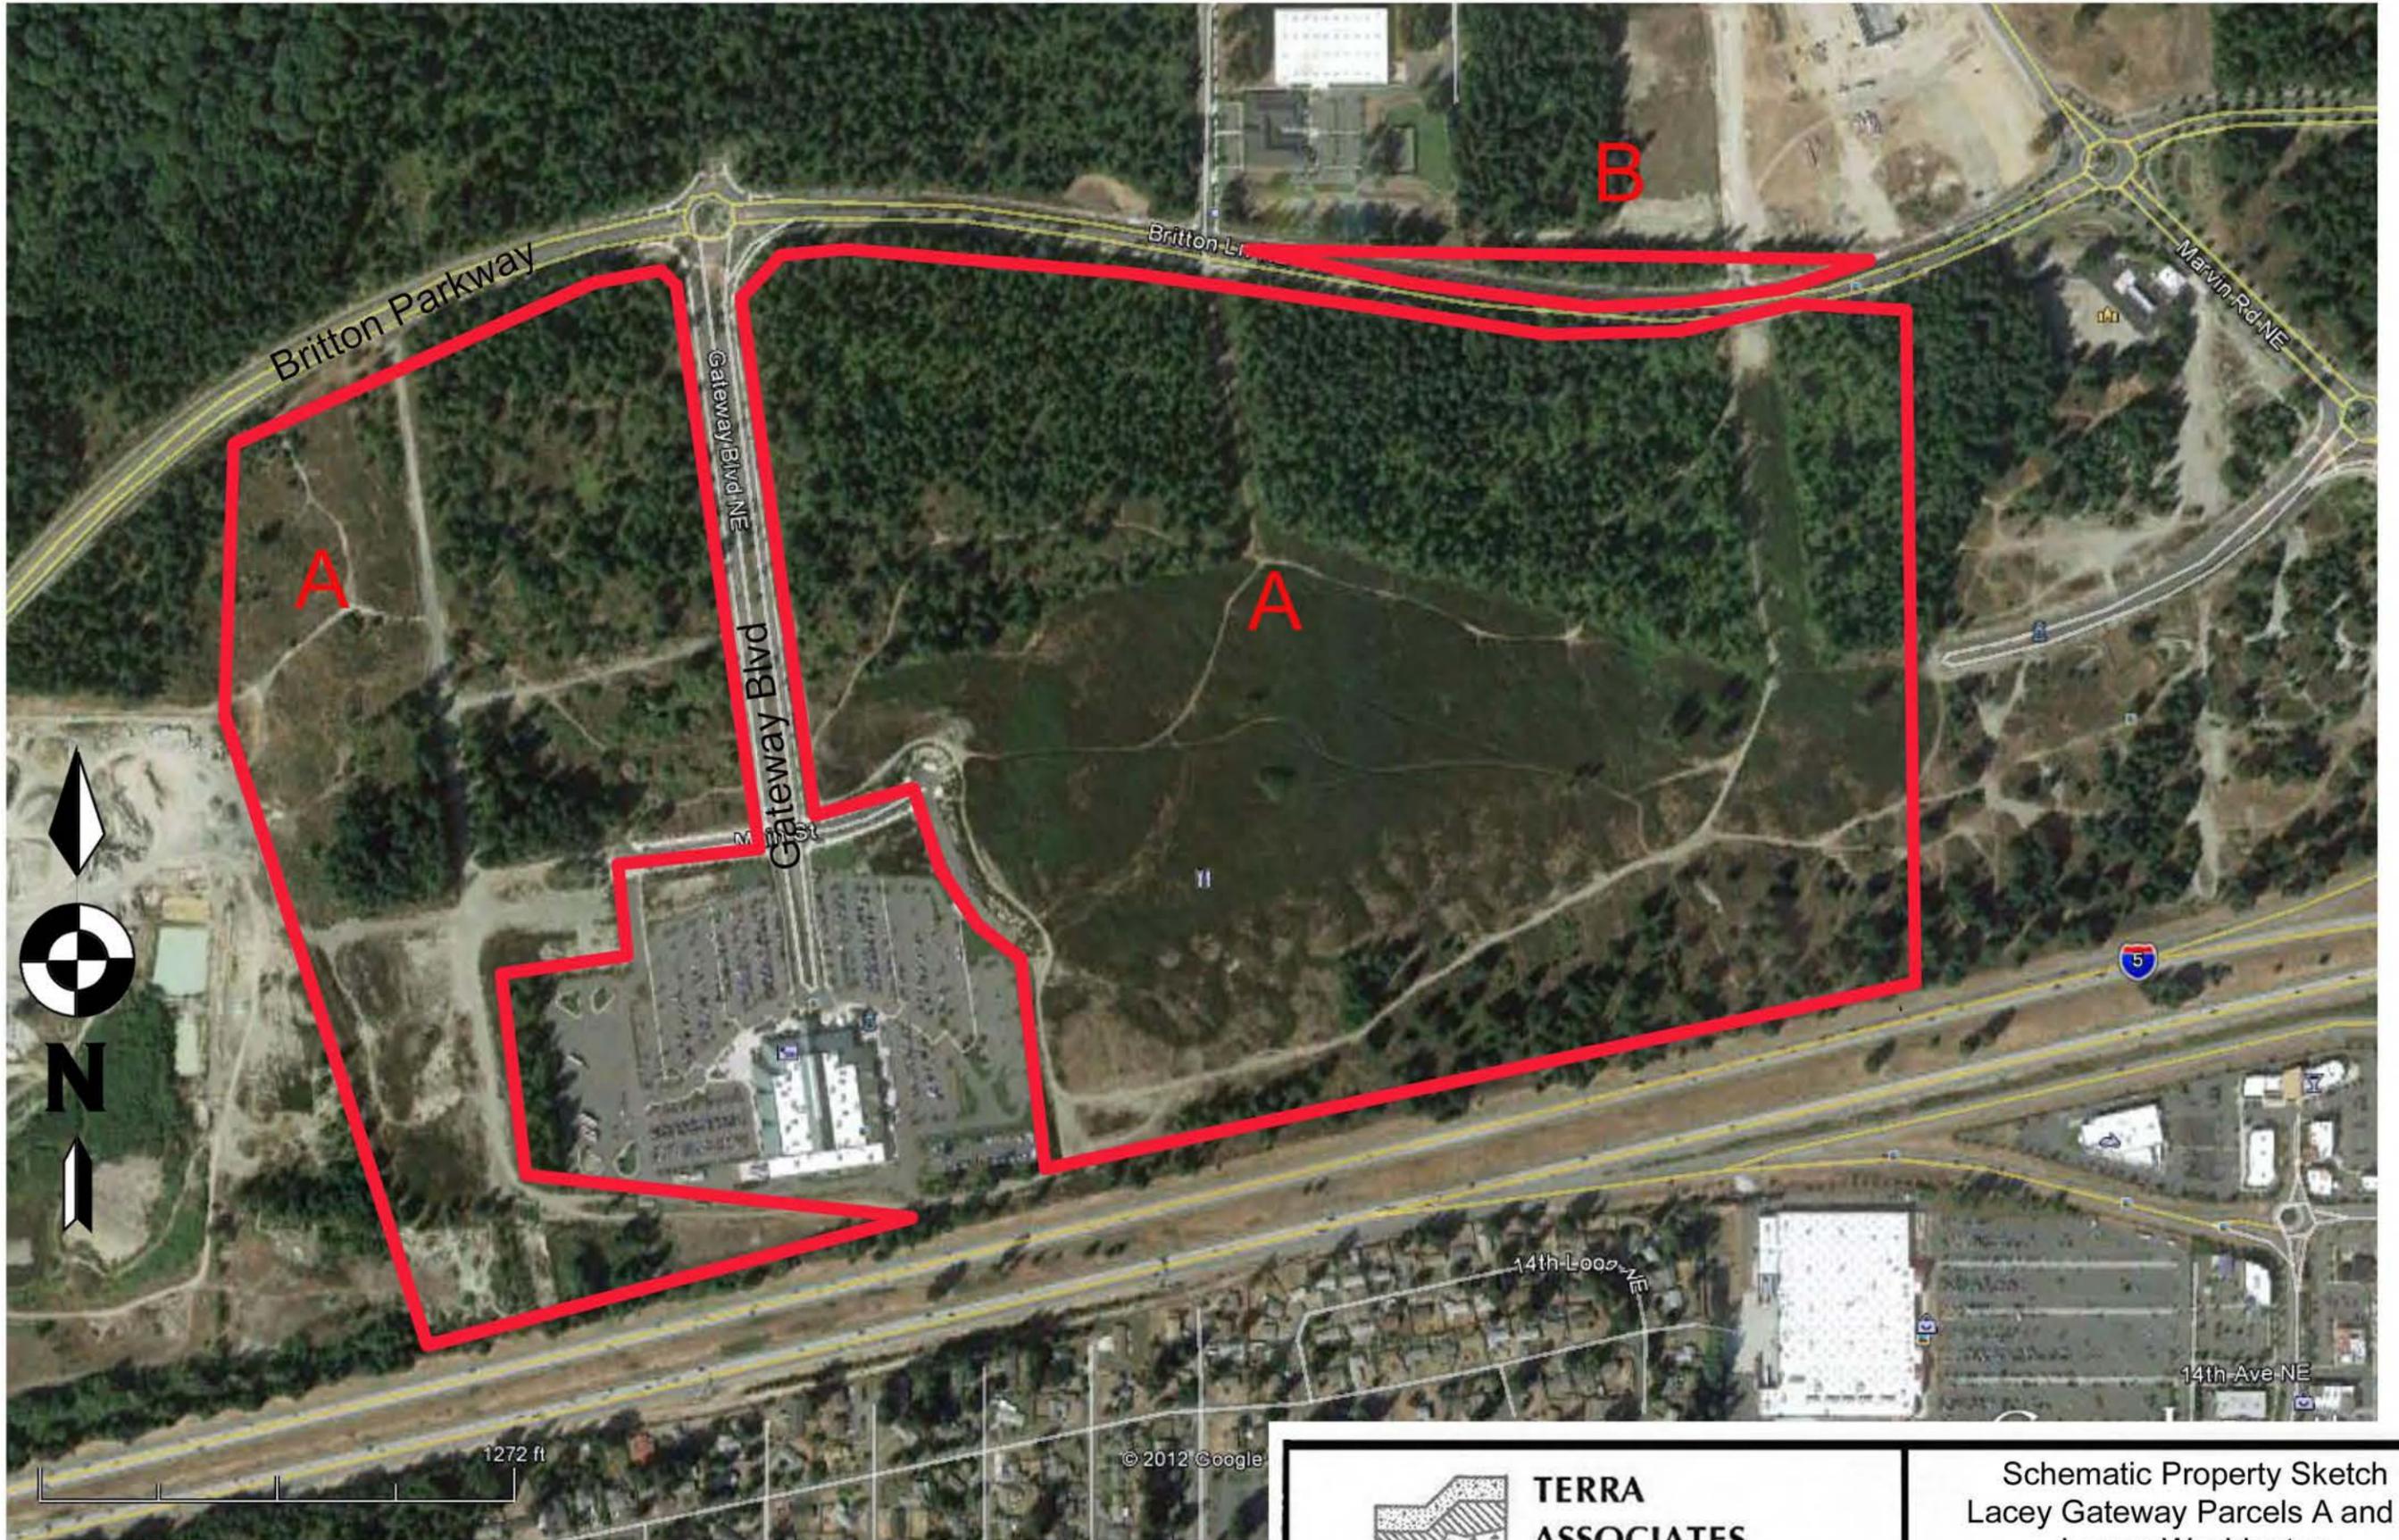
Reference: Google Earth copyright, image dated 2011

The Parcel A and Parcel B are located along the south and north side of Britton Parkway NE west of Marvin Road in Lacey, Washington. The location of the properties and vicinity are shown on Figure 1. Topographic conditions in the vicinity of the properties are presented on Figure 2. Figure 3 shows the existing condition of the properties.

Current Site Conditions are shown on Figure 3.

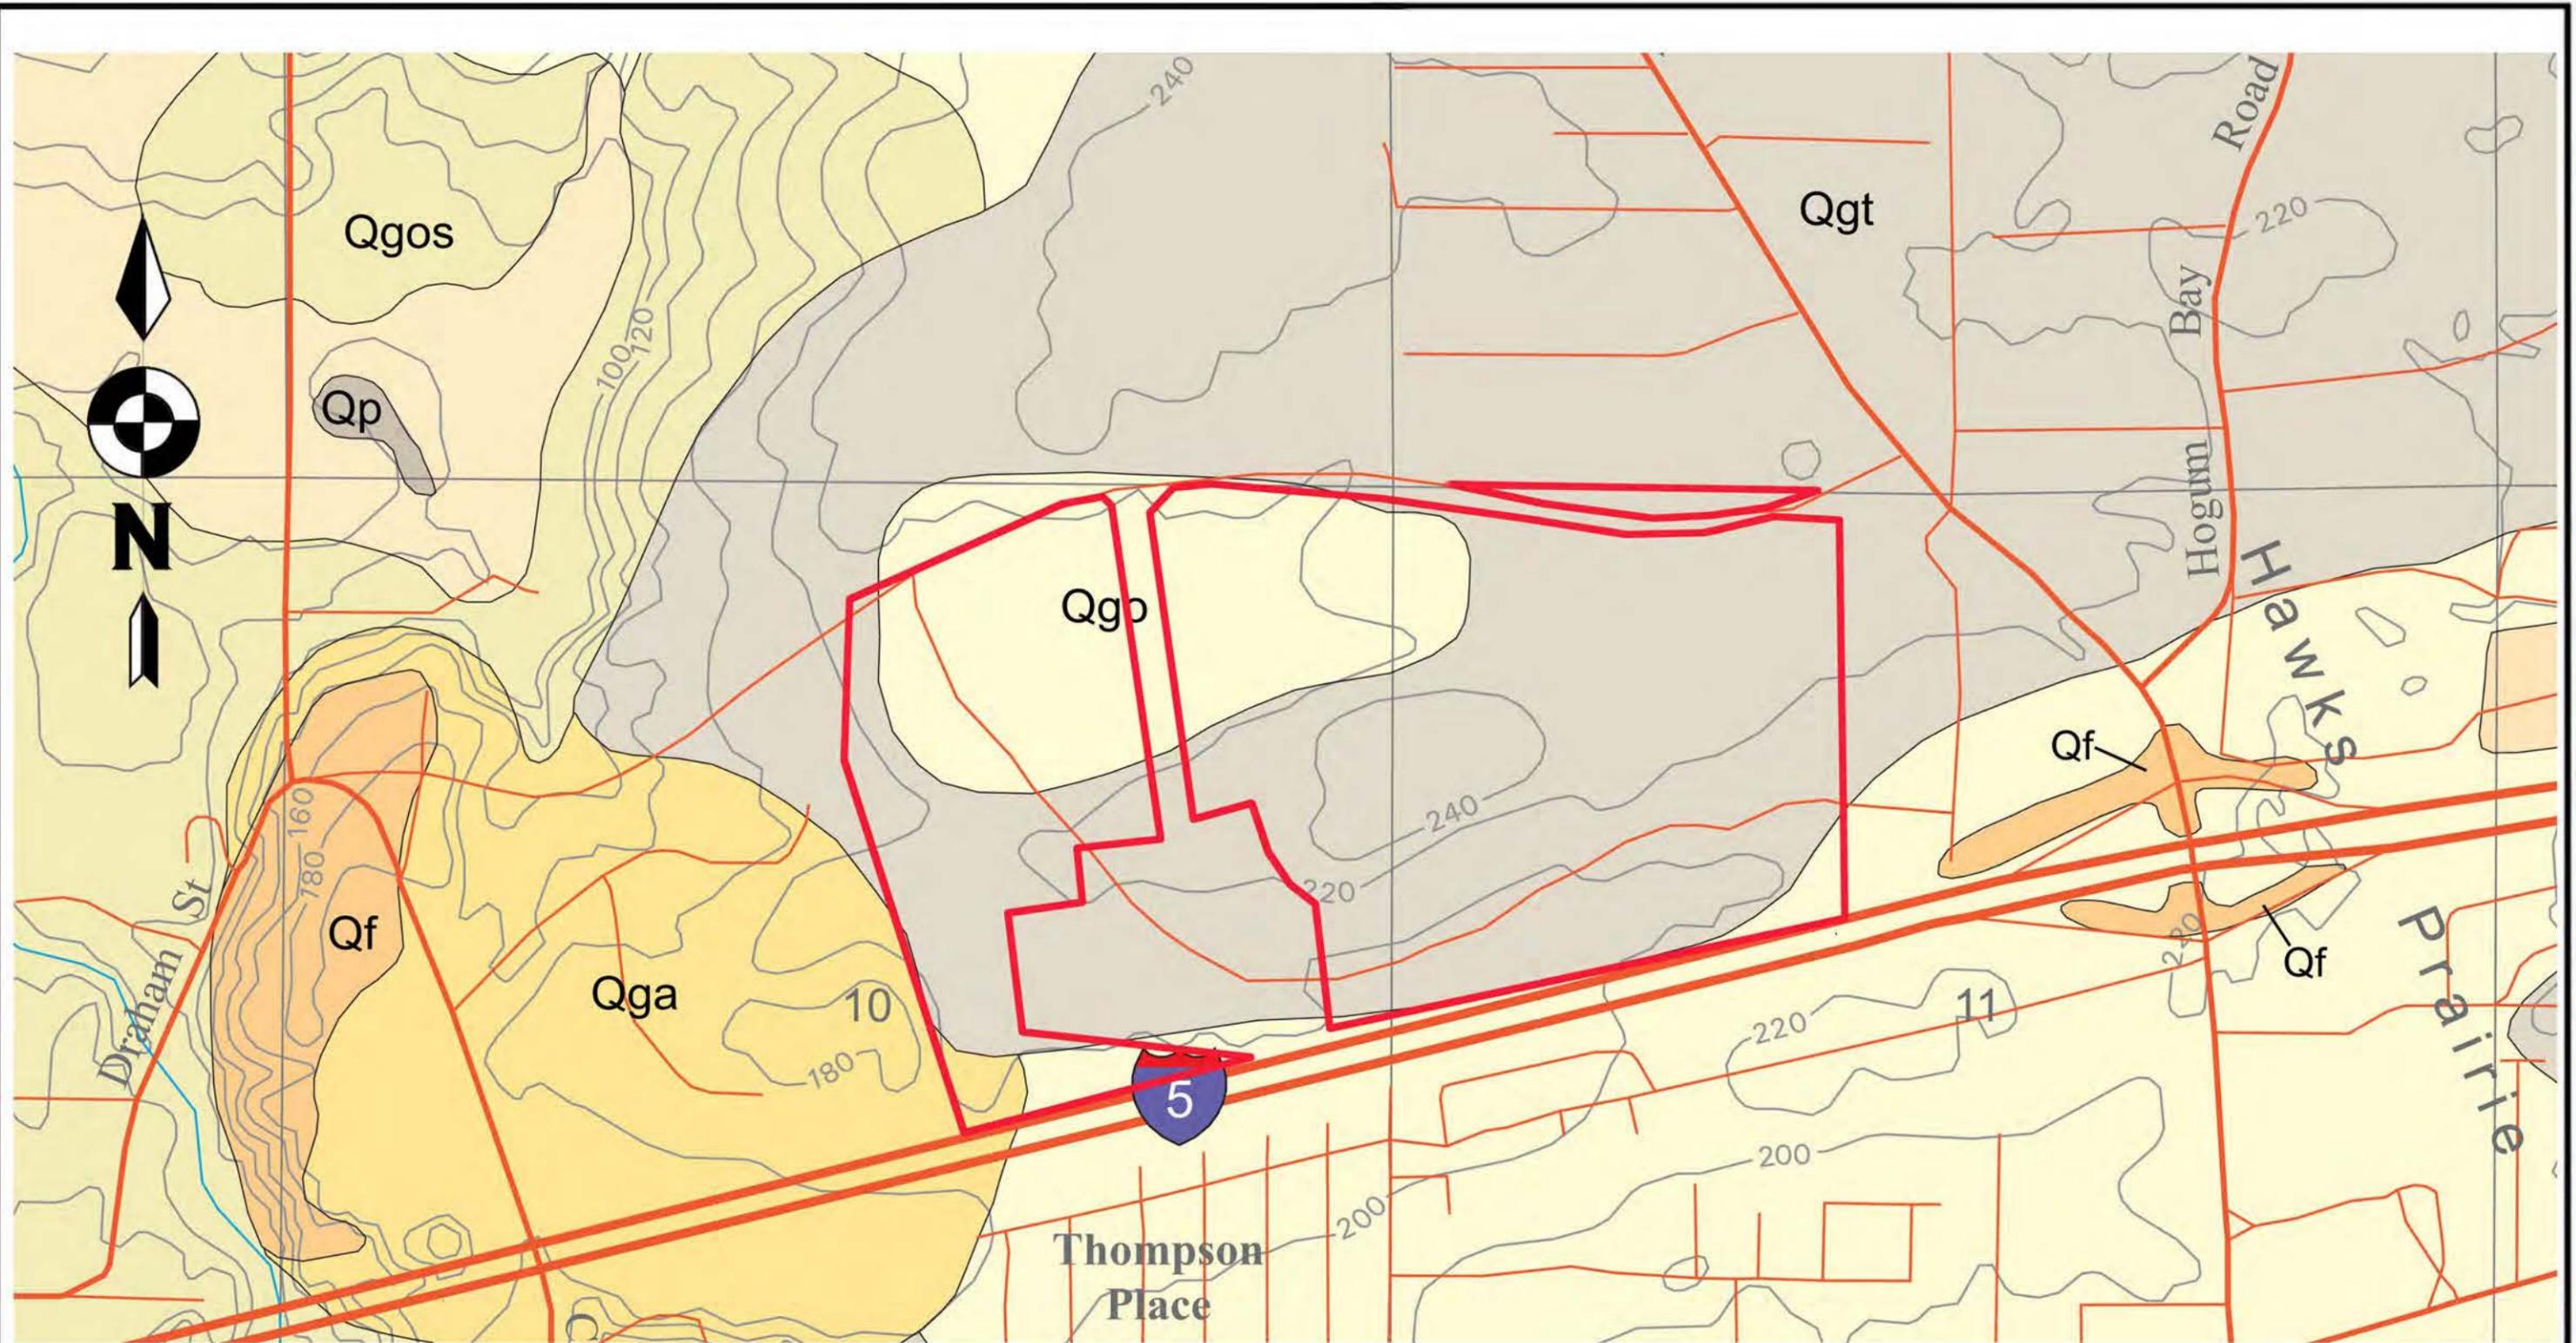
Figure 4

- Legend**
 Qgo Recessional Outwash
 Qgt Vashon Till
 Qga Advance Outwash
 Qf Artificial Fill

Reference: Logan, Robert, et. al, Geologic Map of the Lacey 7.5 Minute Quadrangle, Thurston County, Washington, WDNR 2003

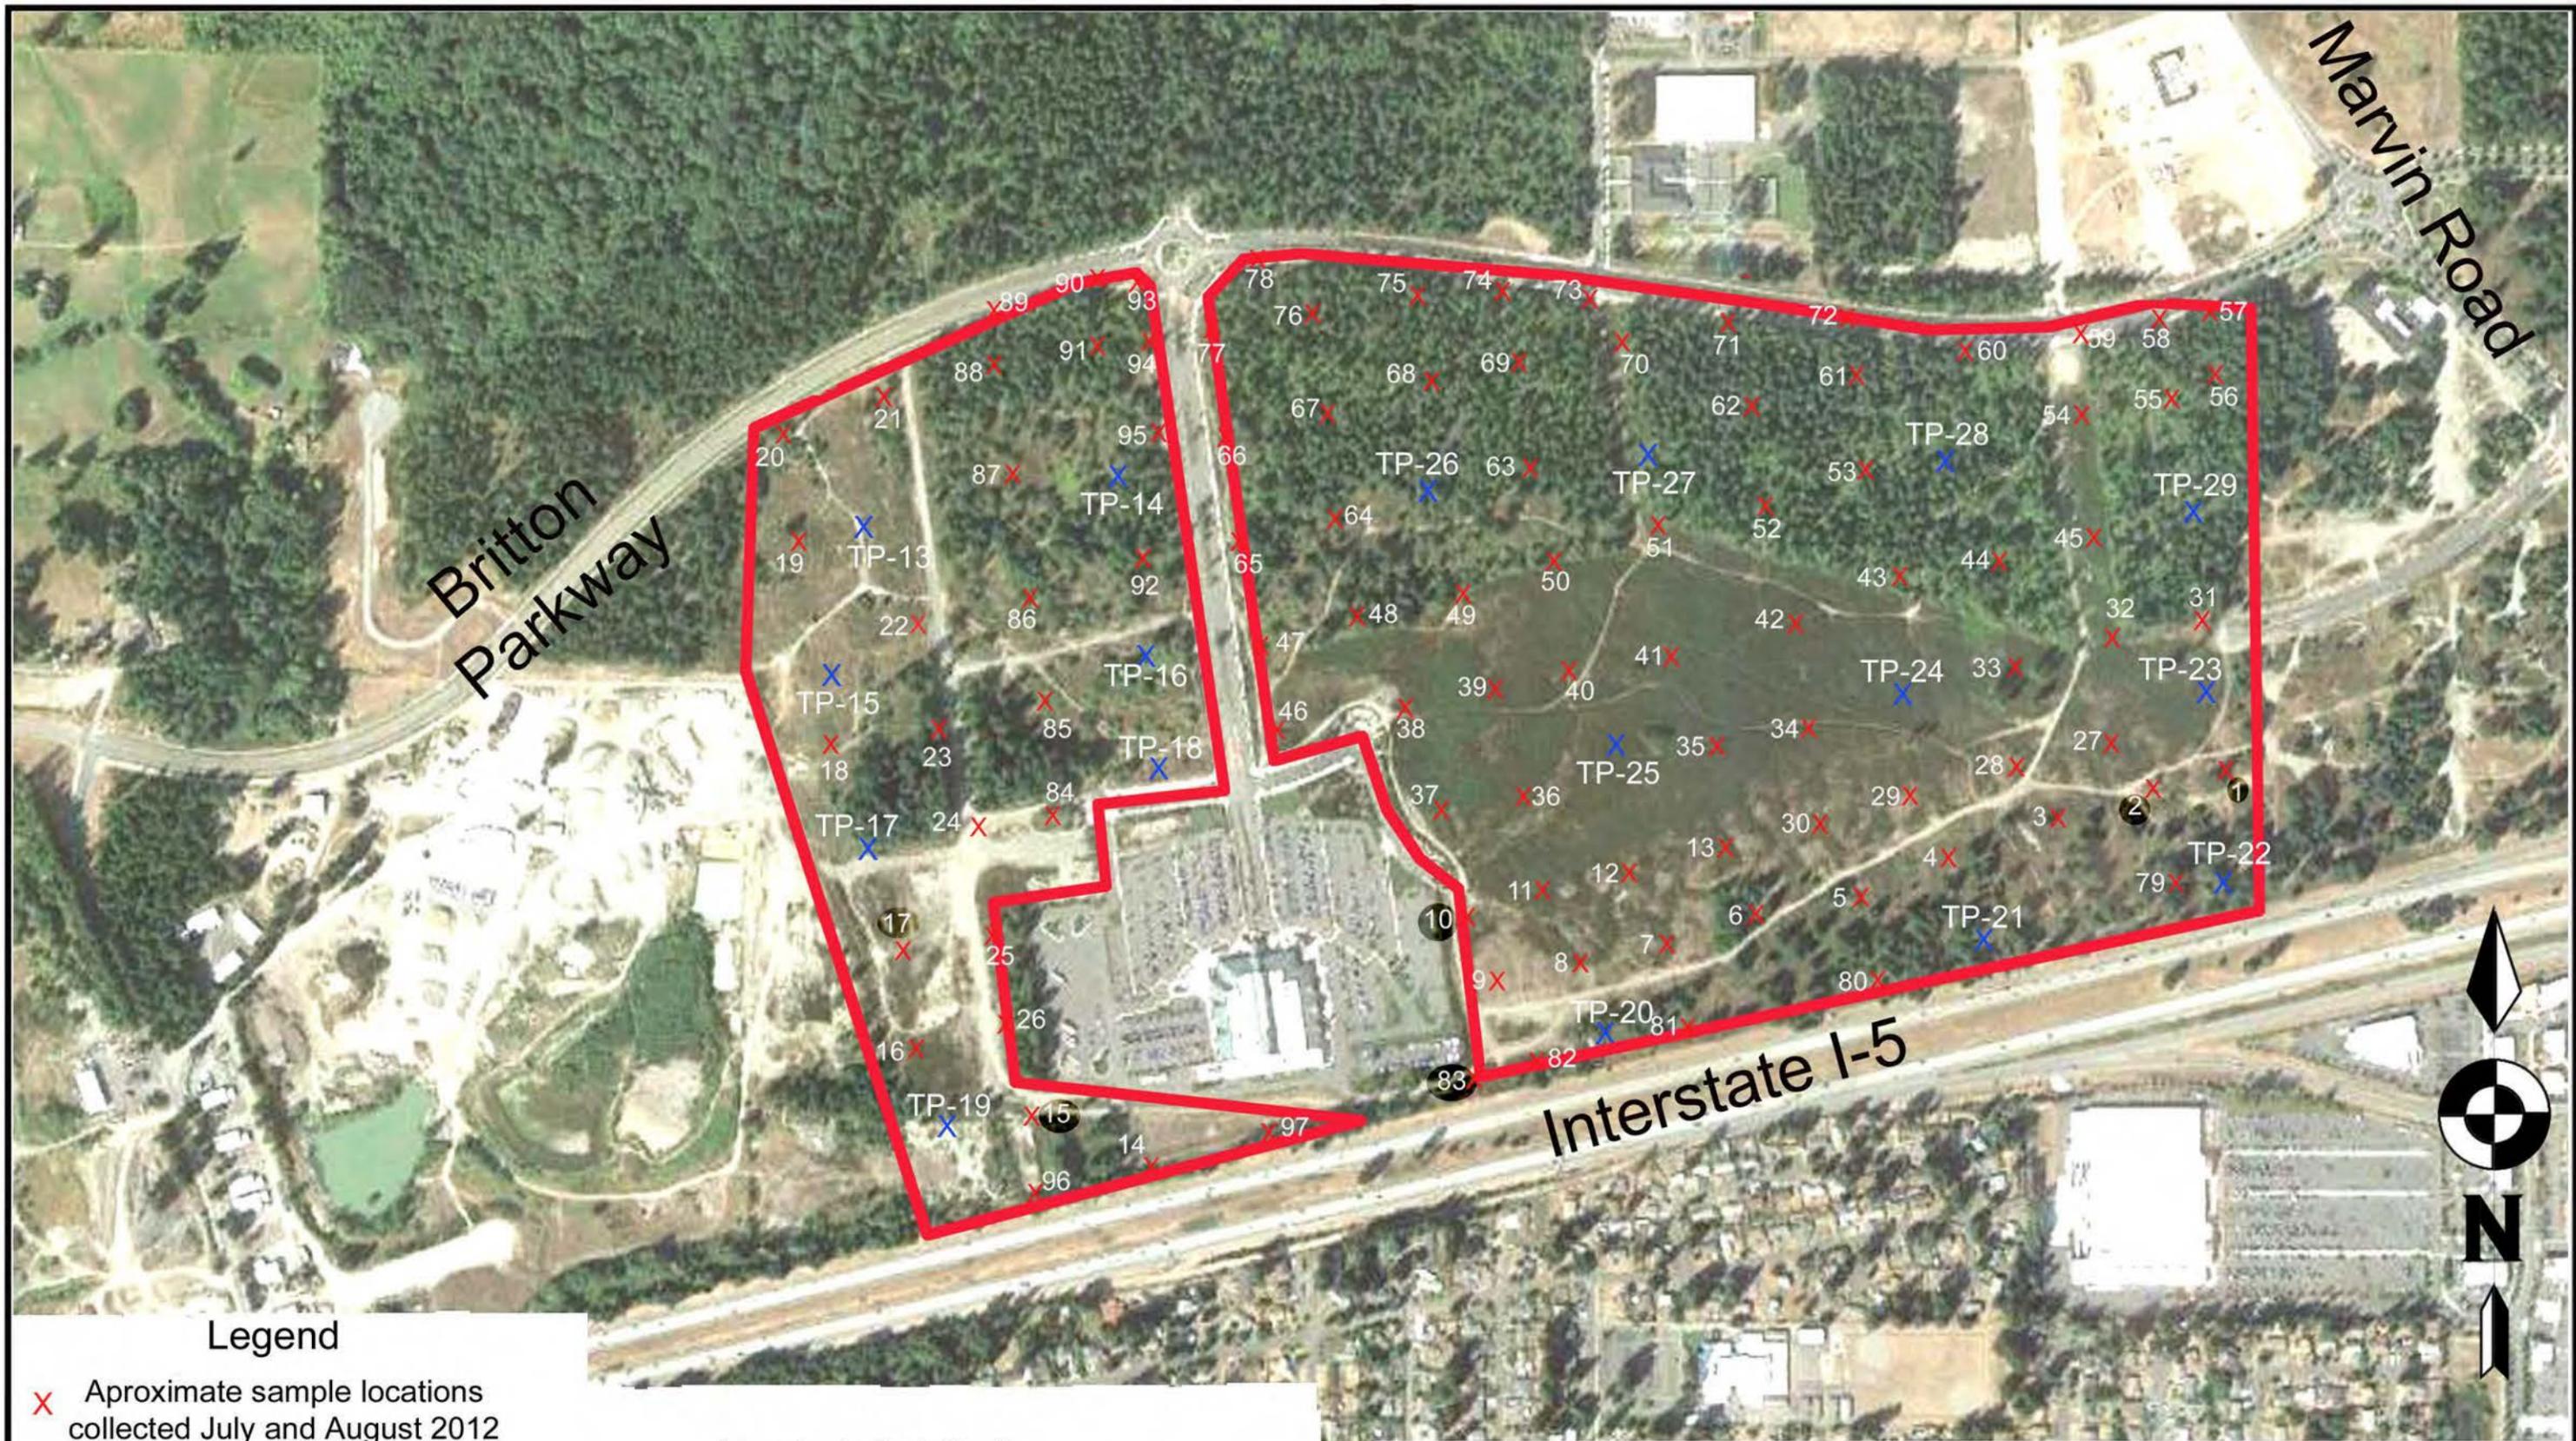
<p>Sample Location Sketch-Parcel A Lacey Gateway Parcels A and B Lacey, Washington</p>		
<p>Proj. No. T-6537-1</p>	<p>Date Sept 2012</p>	<p>Figure 5</p>

- X Approximate sample locations collected July and August 2012
- X Approximate Sample locations collected in 2011

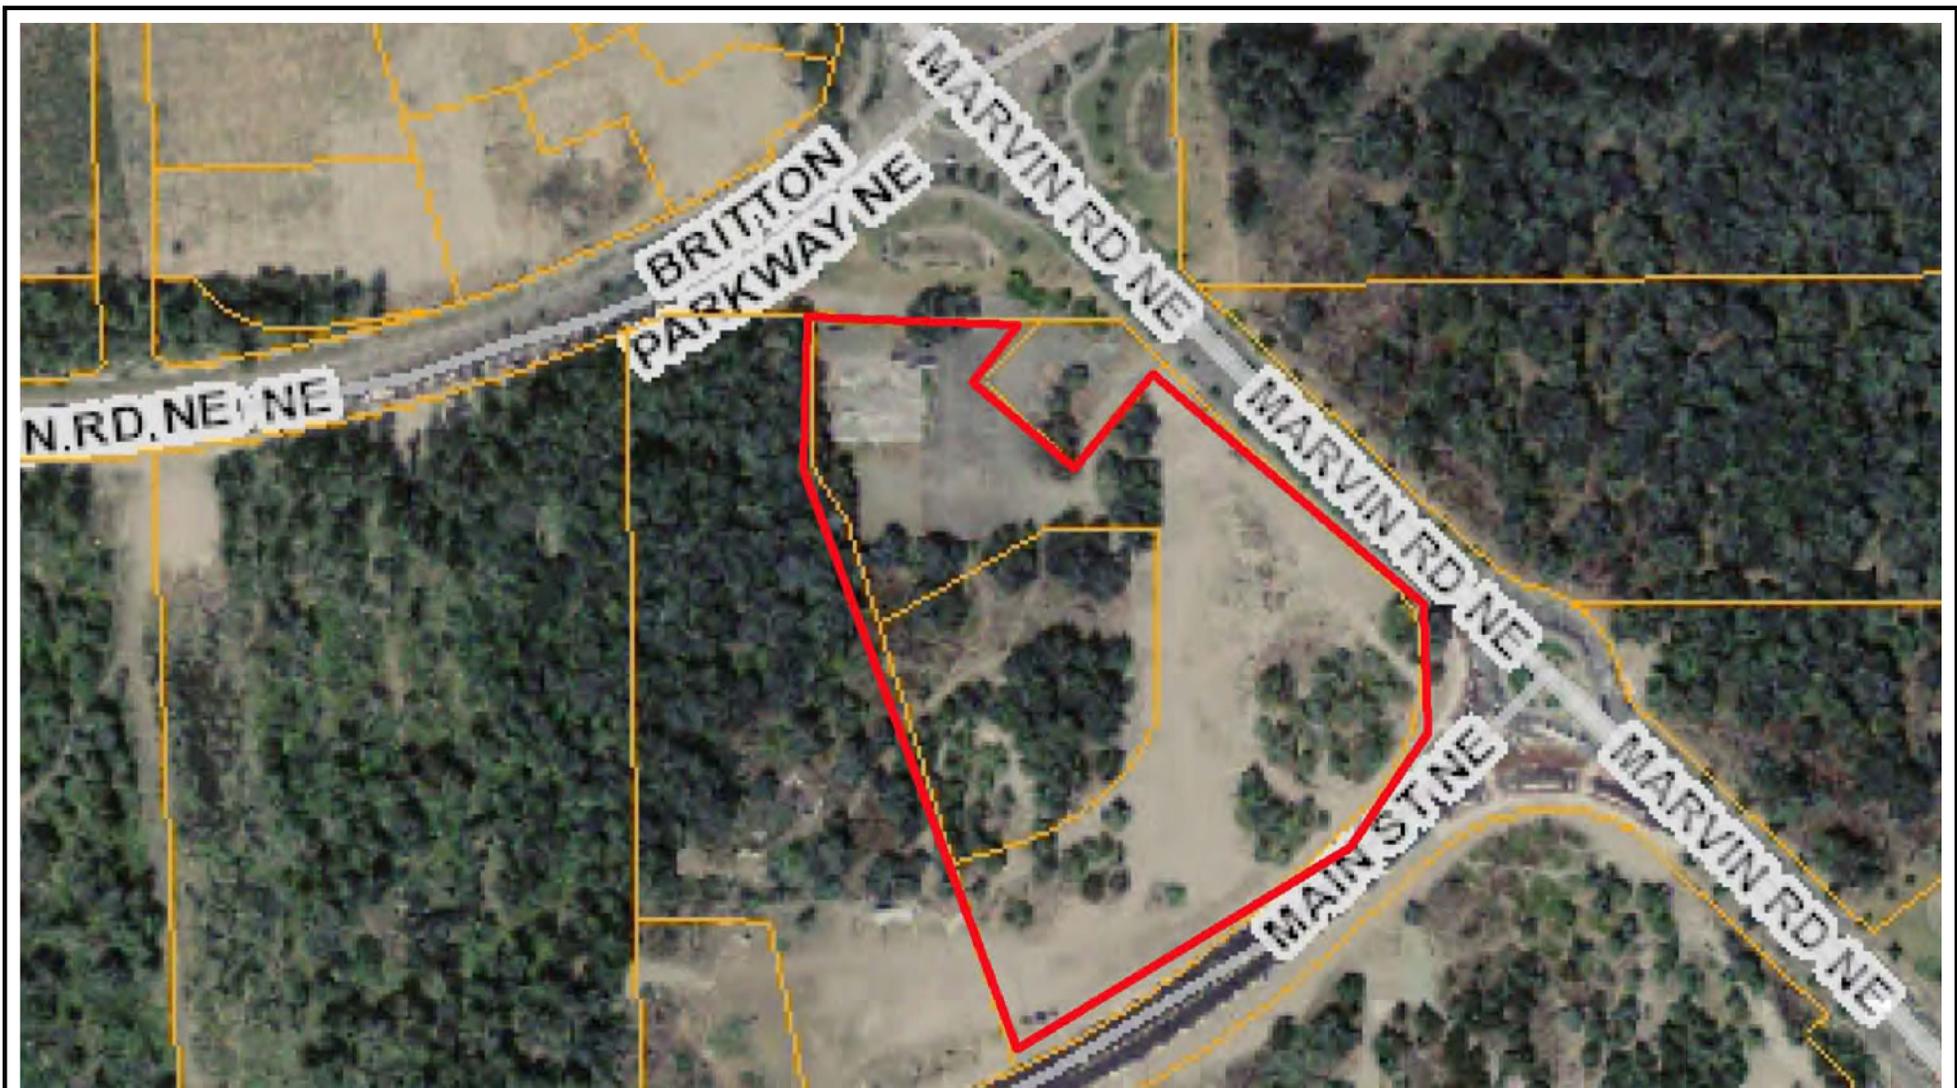
Proj.No.T-6537-7	Date:JULY 2022	Figure 3
------------------	----------------	----------

The project site is an approximately 8.95-acre assemblage of 2 tax parcels located in a generally commercial area of the Hawks Prairie area of Lacey, Washington. The location of the site is shown on Figures 1 and 2. An oblique aerial photo taken of the site is presented on Figure 3.

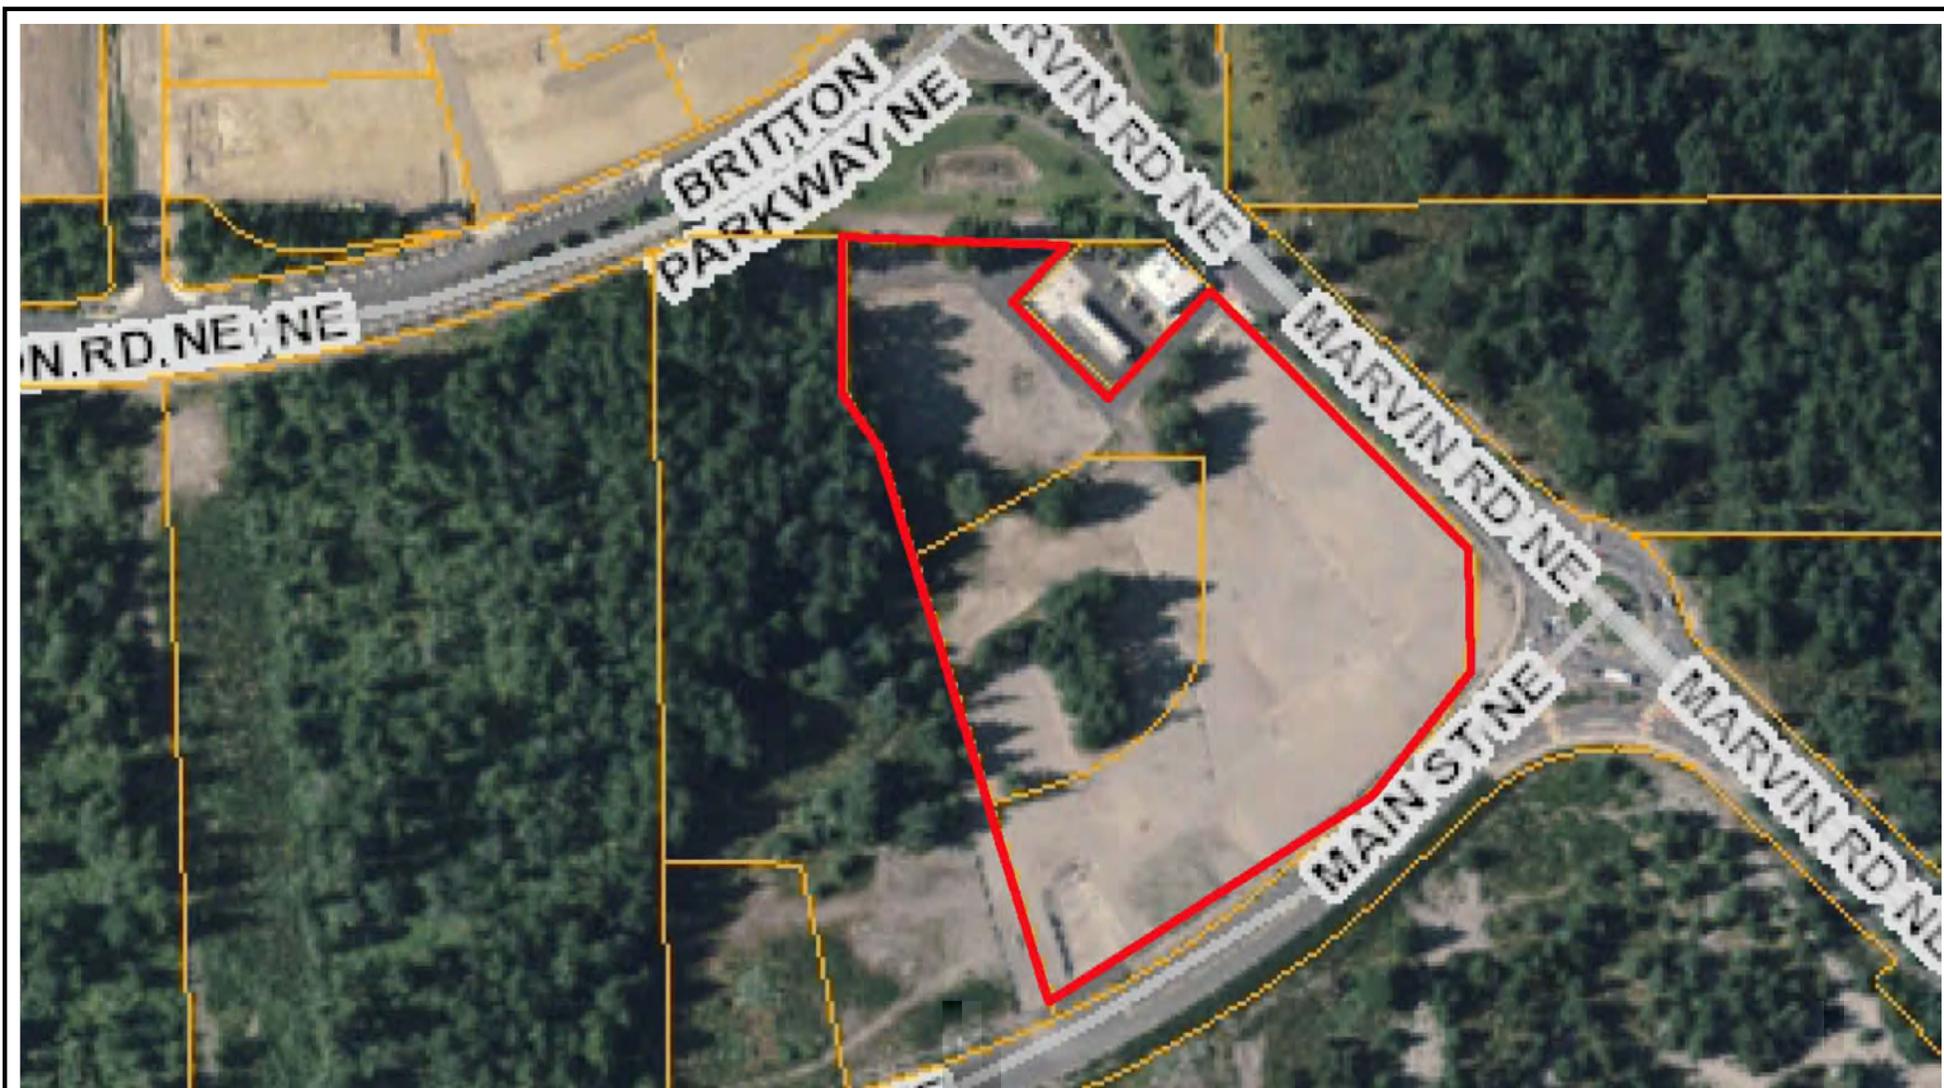
Figure 5 is an aerial photo that shows that, with the exception of the clusters of trees, that the entire site appears to have been cleared and a storm water pond had been excavated in the extreme southwest corner of the site.

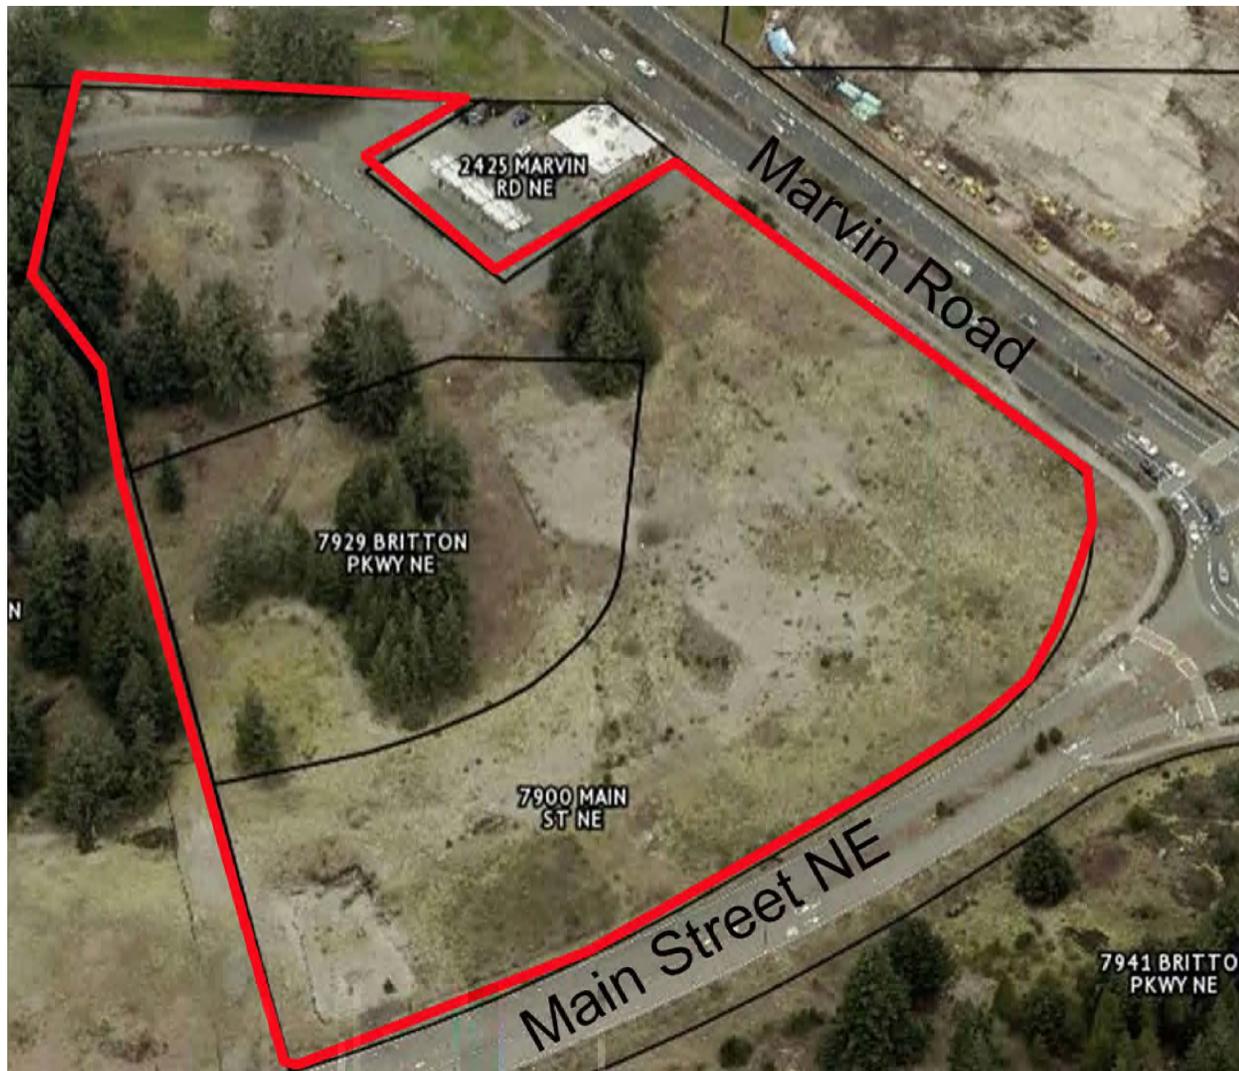
NOTE:
 OBLIQUE AERIAL PHOTO LOOKING NORTH
 PHOTO COPY RIGHT PICTOMETRY
 (IMAGE DATE 2022)

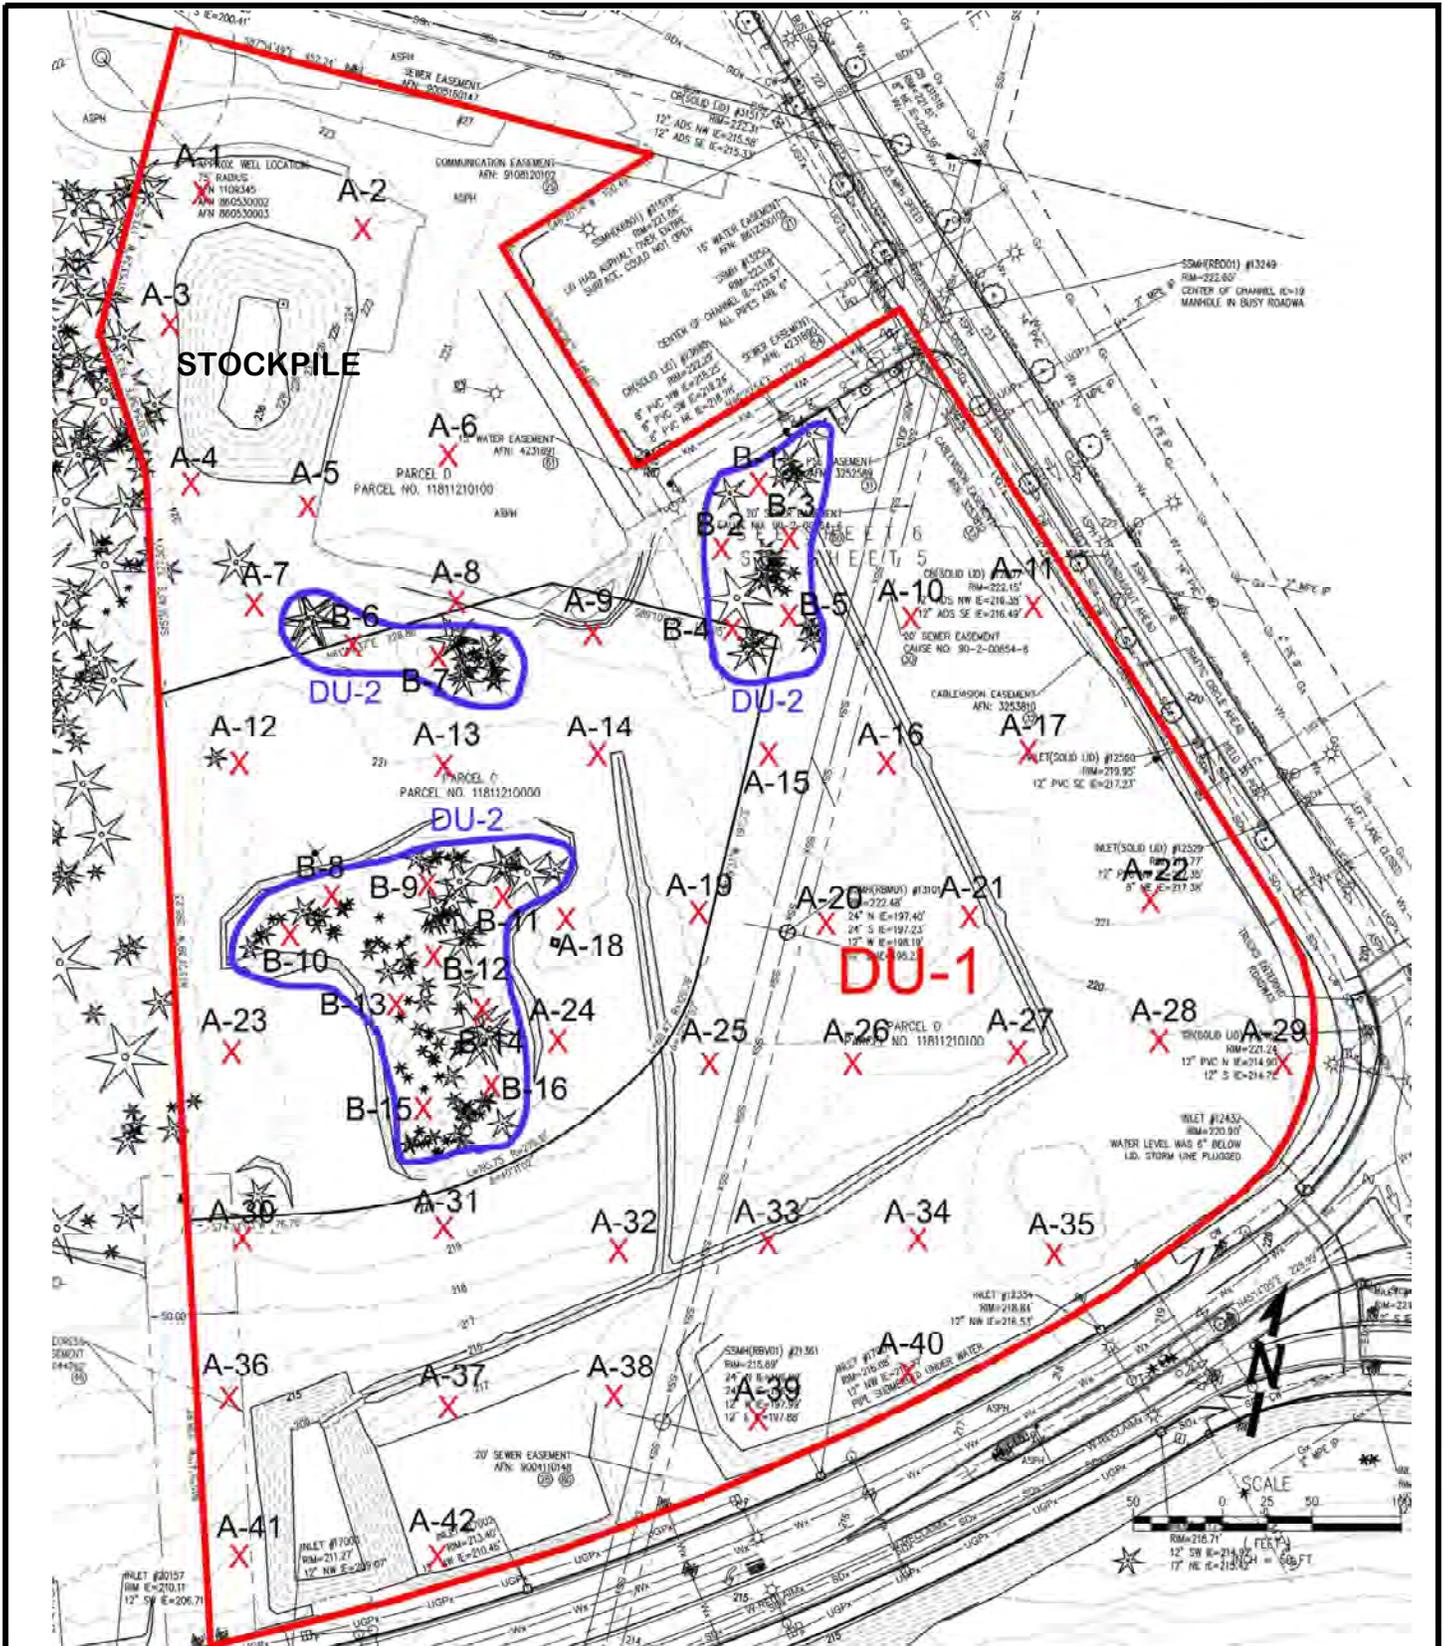
Proj.No.T-6537-7	Date:JULY 2022	Figure 6
------------------	----------------	----------

Figure 1 – Vicinity Map
Figure 2 – Topographic Vicinity Map
Figure 3 – 2022 Oblique Aerial Photo
Figure 4 – 2009 Vertical Aerial Photo
Figure 5 – 2012 Vertical Aerial Photo
Figure 6 – Sample Location Sketch

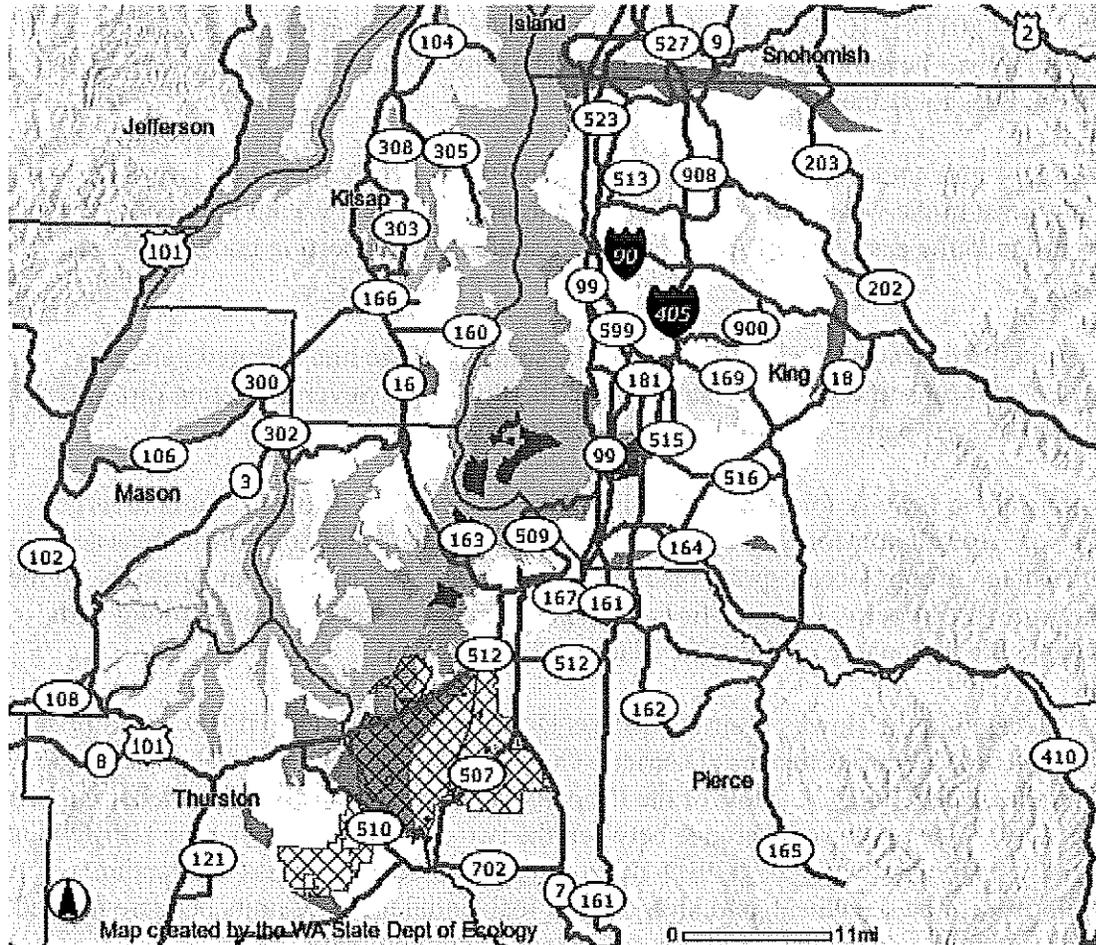
Tacoma Smelter Plume

For almost 100 years, the Asarco Company operated a copper smelter in Tacoma. Air pollution from the smelter settled on the surface soil over a vast region -- more than 1,000 square miles of the Puget Sound basin. Elevated levels of contamination are found as far south as the Nisqually Ridge and as far north as Seattle (West Seattle). Additionally, elevated levels of contamination are found as far west as the Kitsap Peninsula and as far east as Kent and Bellevue. Arsenic, lead, cadmium, and other heavy metals are still in the soil as a result of this pollution. The area has elevated levels of arsenic, lead, and cadmium in the soil due to the Asarco smelter.

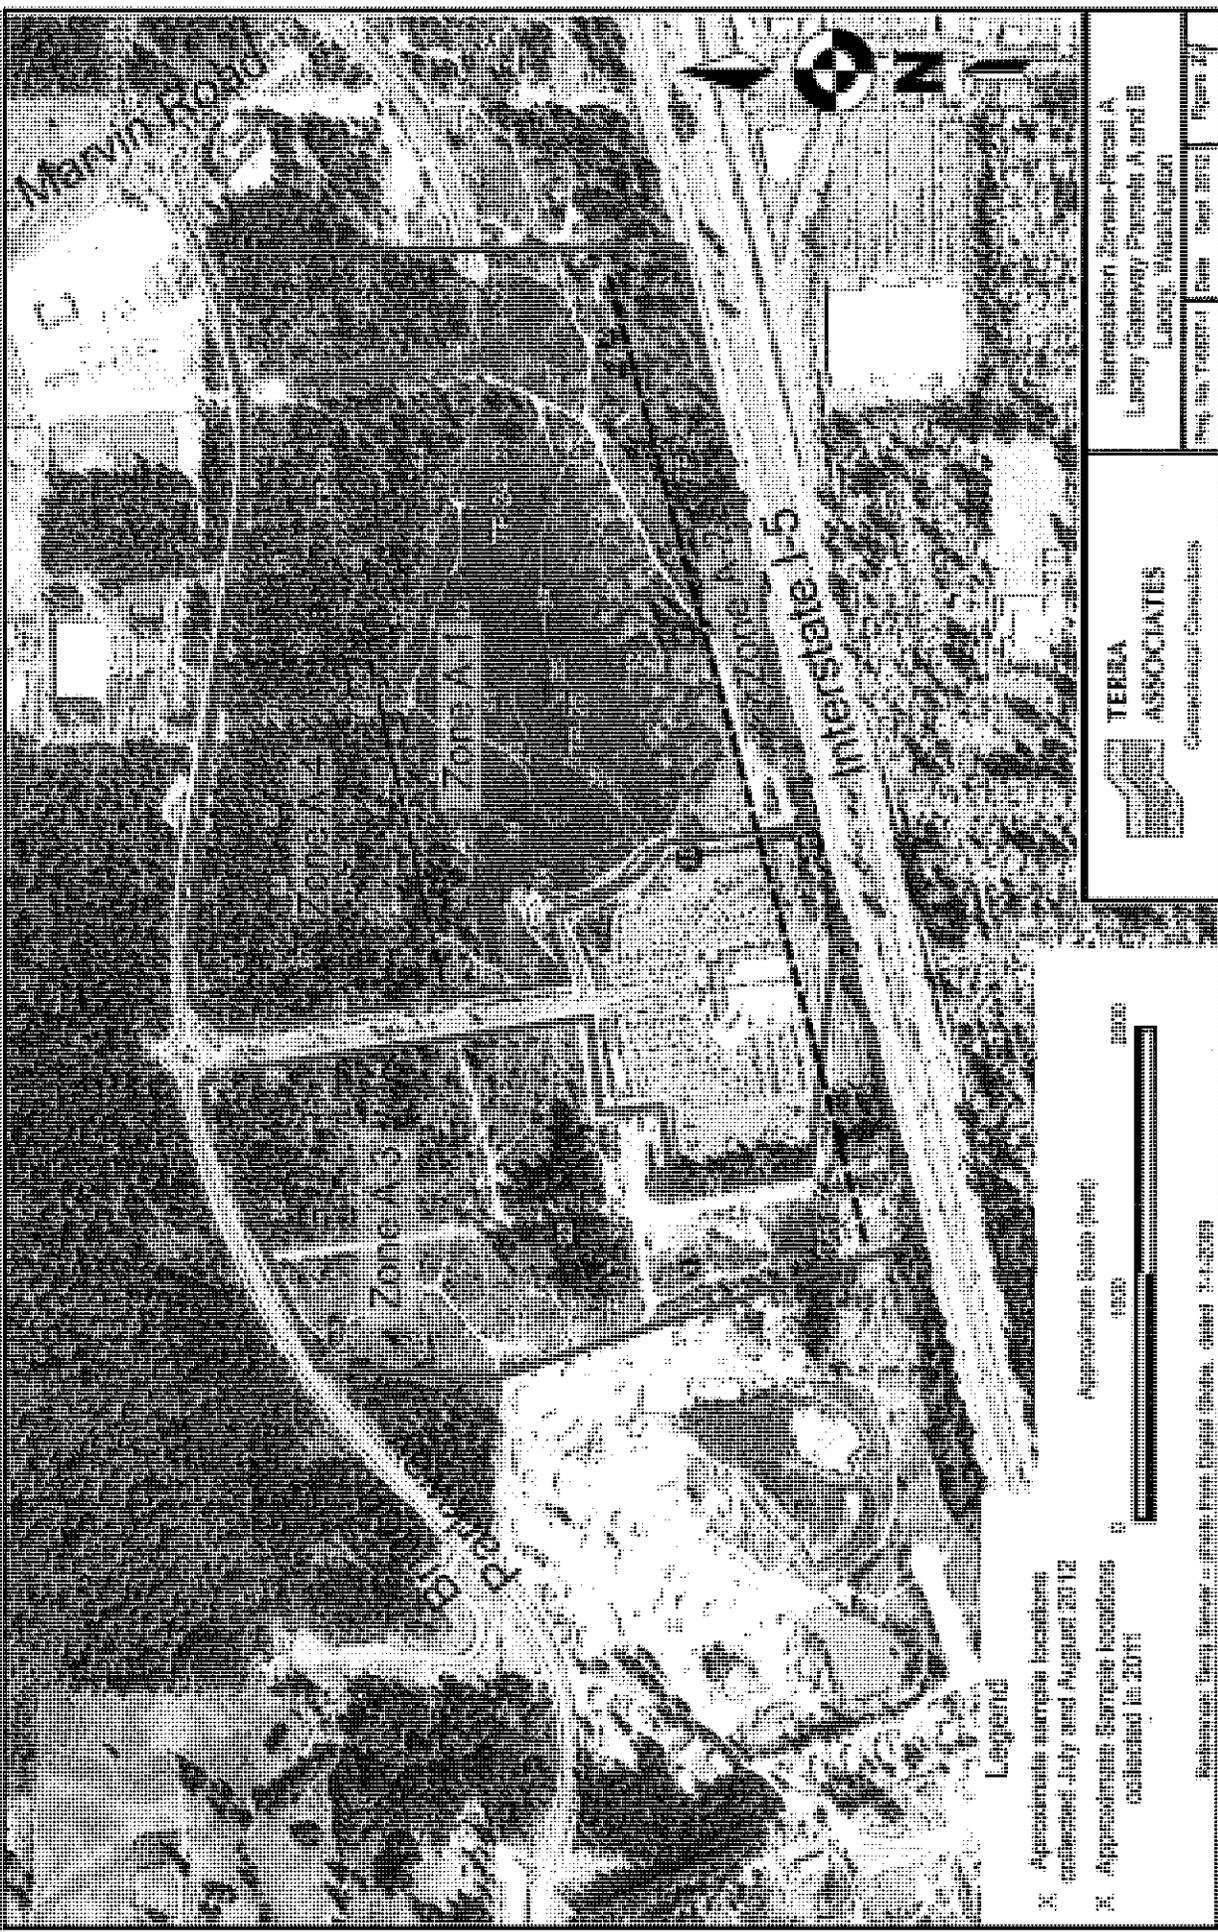
- X. Approximate acreage locations established July and August 2012
- . Approximate acreage locations established in 2011
